Pawtucket/Central Falls Station | Pawtucket, RI

Multimodal Transportation Safety and Efficiency Assessment

May 2017

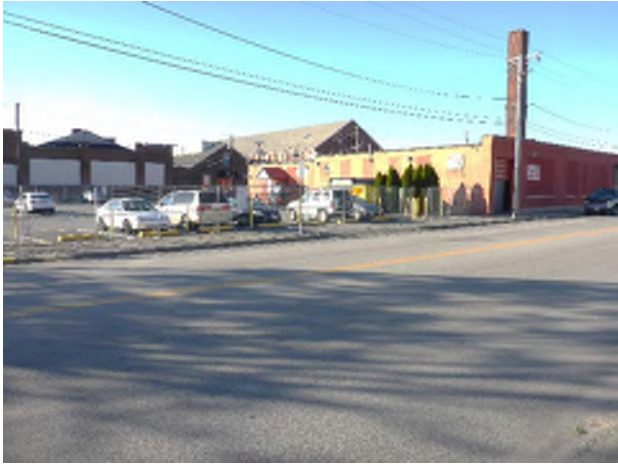
OBSERVATION	TIER 1 AND 2 IMPROVEMENTS	TIER 3 IMPROVEMENTS	COMMENTS
<p>High Vehicle Speeds– Wide pavement and minimal striping leads vehicles to speed, specifically in areas north of the rail road tracks.</p>

<p>ENGINEERING:</p> <p>1.7 Restripe area-wide due to lack of pavement marking visibility.</p> <p>1.8 Utilizing striping to implement a road diet or modify roadway cross sections to provide multimodal accommodations.</p>		
<p>Insufficient vehicle sight lines – Narrow streets with buildings located close to property lines and small turning radii, obstruct sight lines for vehicles to other vehicles and to other roadway users, specifically in areas south of the rail road tracks.</p>

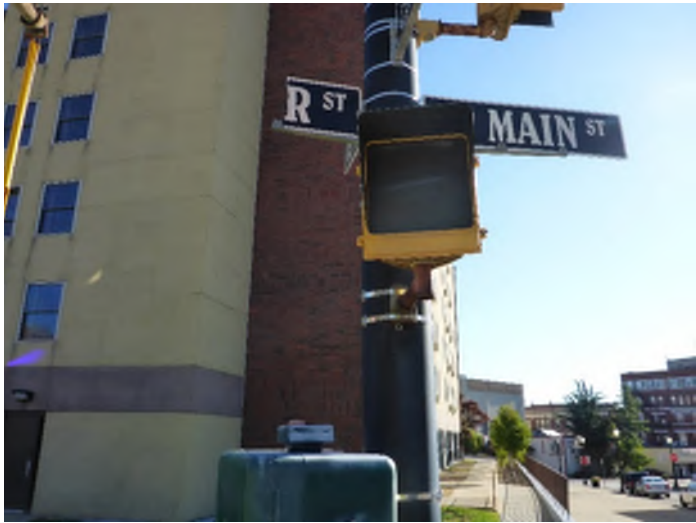
<p>Pedestrian Accommodation Deficiencies– Pedestrian accommodation deficiencies were observed during the field visit, including deficient pedestrian signal equipment, poor visibility, and lack of awareness.</p>

<p>ENGINEERING:</p> <p>3.7 Review pedestrian signal equipment to identify and resolve any issues.</p> <p>3.8 Install ADA compliant wheelchair ramps with detectable warning panels and install pedestrian signal equipment for crosswalks with high pedestrian volume that are unsignalized currently.</p> <p>3.9 Restripe signalized crosswalks with continental style pavement markings for enhanced visibility.</p> <p>3.10 Construct curb extensions to provide improved visibility of pedestrians and shorten the pedestrian crossing distance.</p> <p>3.11 Consider a lead pedestrian interval (LPI) to enhance pedestrian visibility.</p> <p>3.12 Review pedestrian clearance times to ensure sufficient walk and flashing don't walk intervals.</p>	<p>ENGINEERING:</p> <p>3.13 Upgrade pedestrian signal equipment to provide countdown timers, Accessible Pedestrian Signal (APS) push buttons, and detectable warning panels.</p>

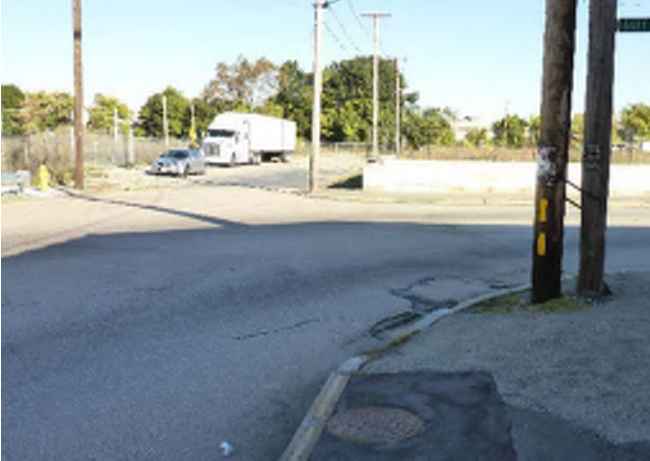
OBSERVATION	TIER 1 AND 2 IMPROVEMENTS	TIER 3 IMPROVEMENTS	COMMENTS
<p>Site Access – The southern access point to the site at the intersection of Pine Street and Goff Street does not have any traffic control. Inadequate bicycle and pedestrian facilities were observed in the vicinity of the station from both southern and northern points.</p>

<p>ENGINEERING:</p> <p>4.6 Enhance traffic control at the intersection of Pine Street and Goff Avenue due to increased volume with an all-way stop controlled intersection.</p> <p>4.7 Coordinate uses of Goff Avenue to meet the needs for all roadway users including emergency vehicles, loading/unloading, pedestrians, bicyclists, vehicles, RIPTA buses. Consider using Pine Street to accommodate some of the needs of the roadway users listed.</p> <p>4.8 Consider a HAWK or RRFB crossing at major crosswalks that provide access to the station.</p> <p>4.9 Consider utilizing Goff Avenue as a primary bike route by revising the cross section to include a bike lane and multimodal accommodations.</p> <p>4.10 Consider utilizing Pine Street (south) as the primary northbound bike route to the station by revising the cross section to include a bike lane and multimodal accommodations. Use Garden Street as the primary southbound bike route from the station.</p>	<p>ENGINEERING:</p> <p>4.11 Develop a pedestrian and bicycle path at Andrew Ferland Way to accommodate multimodal traffic (particularly if overflow parking is located here). Consider HAWK or RRFB if Andrew Ferland Way is designated a key crossing.</p> <p>4.12 Install a roundabout at the intersection of Pine Street and Goff Avenue due to increased volume.</p>	<p>Item 4.6 was also recommended in the 2015 Traffic Impact and Access Study by GRA.</p> <p>Due to limited parking areas adjacent to the platforms, overflow parking may be located off Andrew Ferland Way. There is additional space between existing buildings to provide a separated area designated for pedestrian and bicycles to access the future station without walking/operating along Dexter Street.</p> <p>A HAWK is a High Intensity Activated Crosswalk, which is a signal that is used at major pedestrian crossing if it meets warrants provided in the MUTCD are met.</p> <p>A RRFB is a Rectangular Rapid Flashing Beacon, which is a flashing beacon used to supplement warning signage to provide enhanced awareness.</p>

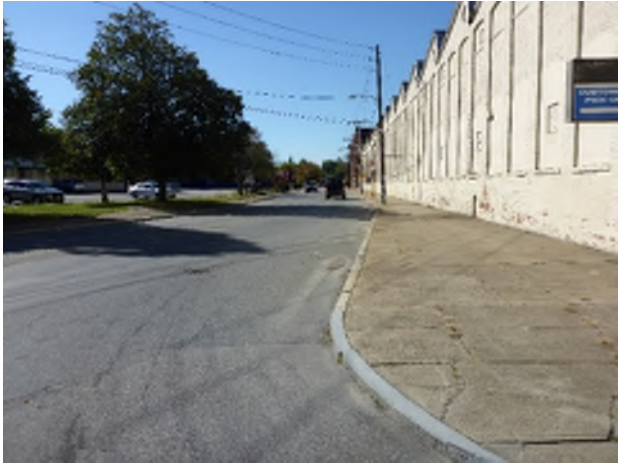
5.0 Barton Street			
<p>Wide pavement and horizontal curves – The wide pavement width and lack of pavement markings encourages high speeds and leads to drivers crossing the double yellow line on horizontal curves.</p>

<p>ENGINEERING:</p> <p>5.1 Consider installing speed tables to reduce speeds along the corridor due to the increased number of pedestrian and vehicular activity.</p> <p>5.2 Revise roadway cross section to accommodate bike lanes in each direction with a buffer where possible.</p> <p>5.3 Install additional signage to enhance the horizontal curves along the corridor.</p> <p>5.4 Create a gateway to the site that is welcoming for all users.</p>		<p>As part of the 2013 Statewide Horizontal Curve delineation project, additional curve warning signs were previously installed.</p>

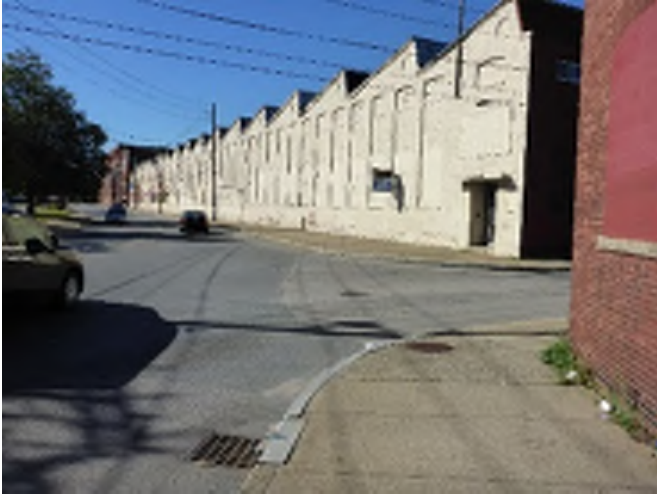
OBSERVATION	TIER 1 AND 2 IMPROVEMENTS	TIER 3 IMPROVEMENTS	COMMENTS
<p>Inadequate Pedestrian Facilities – The proposed northern entrance to the station will be on Barton Street and a midblock crossing will likely be installed. Pedestrian facilities are not adequate to accommodate an increased number of pedestrians due to the lack of visibility along Barton Street caused by limiting sight lines.</p>

<p>ENGINEERING:</p> <p>5.5 Construct curb extensions to provide improved visibility of pedestrians and shorten the pedestrian crossing distance.</p> <p>5.6 Consider a HAWK or RRFB crossing at the major crossings adjacent to the entrance to the station.</p> <p>5.7 Reconfigure Barton Street at Pine Street intersection to improve sight lines for vehicles, pedestrians, and bicyclists.</p>	<p>ENGINEERING:</p> <p>5.8 Reconstruct sidewalks where they are deteriorated or inadequate along pedestrian routes to the station. (Outside what is listed in Item 1.1)</p> <p>5.9 Install ADA compliant wheelchair ramps with detectable warning panels and install pedestrian signal equipment for crosswalks with high pedestrian volume that are unsignalized currently.</p>	<p>A HAWK is a High Intensity Activated Crosswalk, which is a signal that is used at major pedestrian crossing if it meets warrants provided in the MUTCD are met.</p> <p>A RRFB is a Rectangular Rapid Flashing Beacon, which is a flashing beacon used to supplement warning signage to provide enhanced awareness.</p>

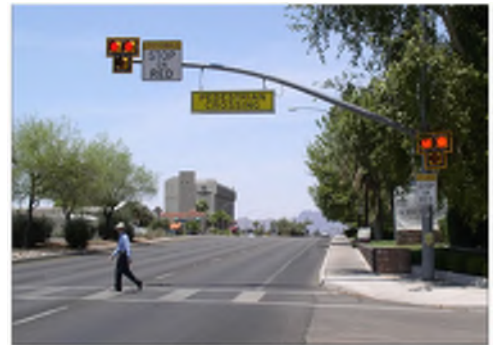
Figure 3-3 High-Intensity Activated Crosswalk (HAWKs)³

High-intensity Activated Crosswalks (HAWKs), as depicted below, consist of a signal face made up of three sections. Two red lights are mounted side by side above one centered yellow light. When activated by a pedestrian this combination of lights is used to slow vehicles to a stop, protect the pedestrian movement while crossing, and transition back to the vehicle movement when the pedestrian walk phase has ended. The system can be activated manually by a push button or by a passive system, which means that the presence of a pedestrian is enough to activate the signal, no push button is needed. This system should be installed at least a 100 feet from side streets or driveways that are controlled by stop or yield signs.

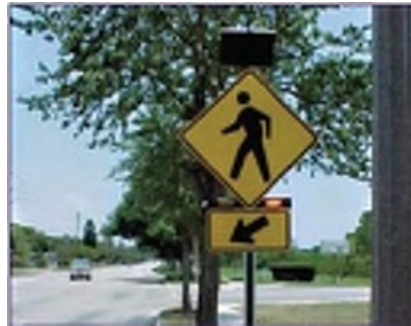
Figure 3-4 Rectangular Rapid Flashing Beacons (RRFBs)⁵

Rectangular Rapid Flashing Beacons (RRFBs), as depicted below, are user activated LEDs that supplement MUTCD compliant warning signs at unsignalized intersections or mid-block crosswalks. The system can be activated manually by a push button or by a passive system.
